US Application 10/591,313
Declaration of Inventor Gerard Short

Title: PAINTABLE PRIMER SYSTEM

DECLARATION UNDER 37 C.F.R. § 1.132 of Mr. Gerard Short

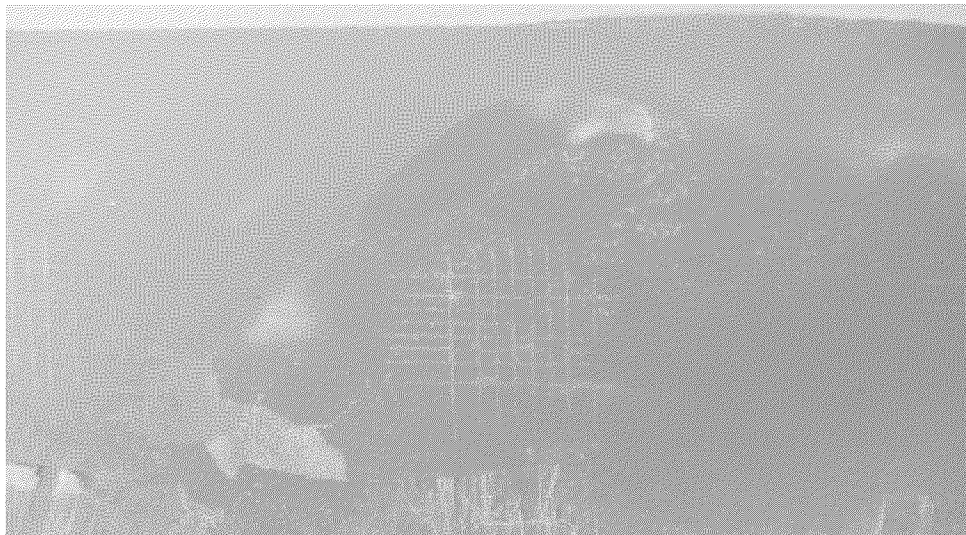
2024T3 Series

LUC3 Primer - On the 10th March a white spot of aluminium oxide was detected on the top coated section marked LUC3 on both the 2000 and 7000, located on the line of the cross hatching performed prior to the salt bath immersion (attached below).

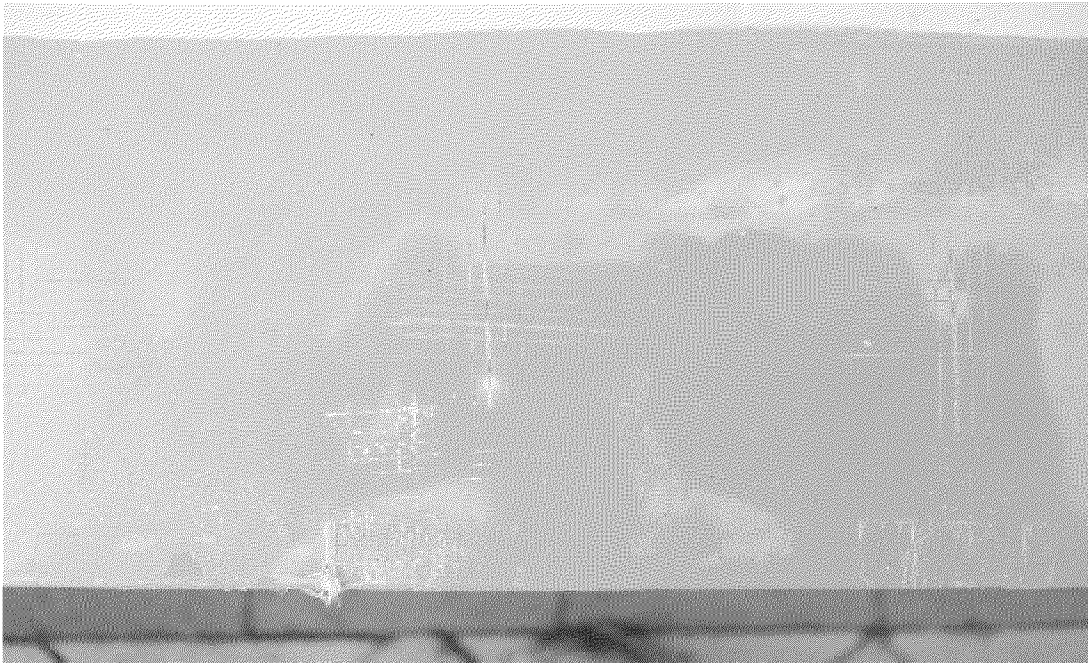
7075T6 Series

Note: The white portion shown below the cross hatching is the thread of the 8981 tape applied and left on the substrate after the initial cross hatching. The salt water destroyed the tape but left the thread.

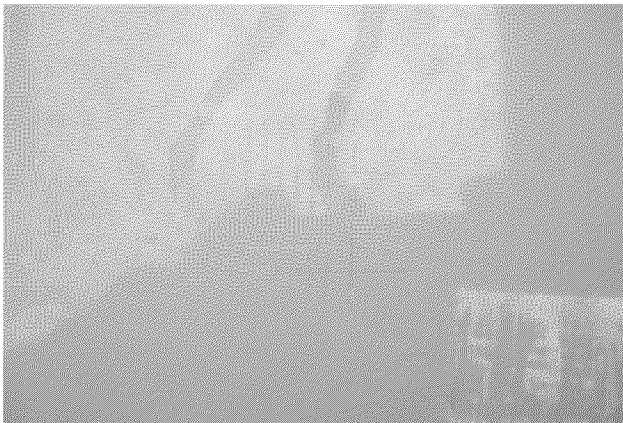
Top Coated LUC4 (2024 series)

On examination of the other coatings, notably LUC4 and the Std RCP001, it appears that there is a darkening of the metal on the scribe lines of the cross hatching but as shown on the pictures below there is no aluminium oxide build up evident as at the 18th March, 2009

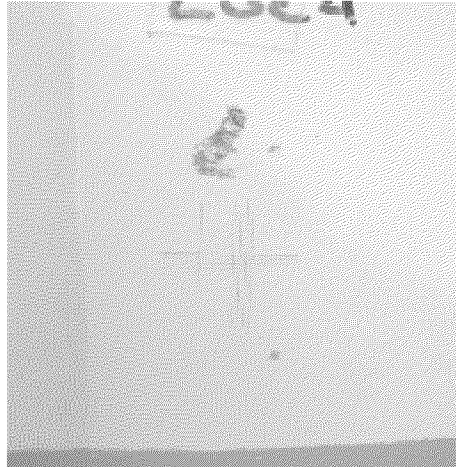
Primer Only LUC4 (2024 series)

Note: The brown mark on the primer LUC4 is bird dropping that occurred while the panel was out of the Salt bath. It was decided not to clean the contaminated area and see the effect on the primer.

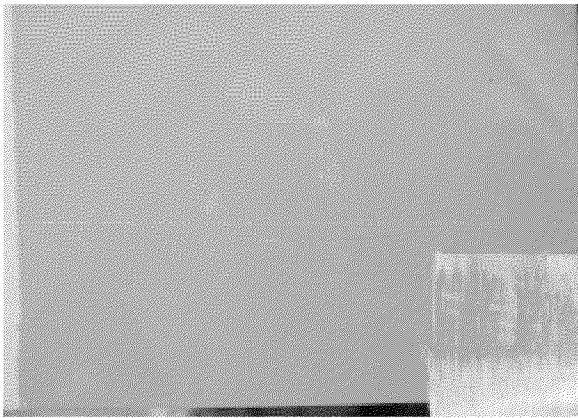
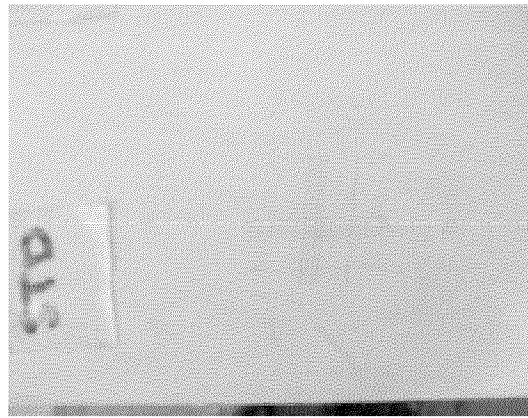
There does not appear to be a great difference between the LUC4 and the Std RCP001 to date. The completion of the actual salt spray test will clarify the long term effects on these two primers.

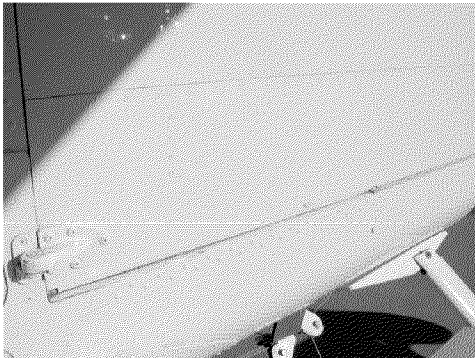
This left hand picture shows the port side rear cabin door of the seaplane.

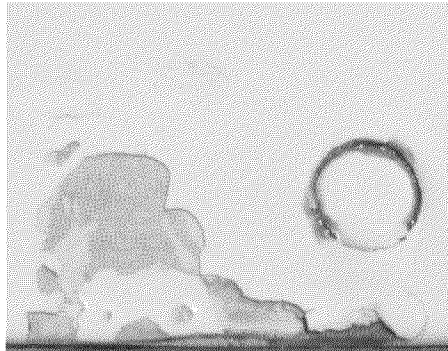
This picture shows a damaged area of the cabin door which has been exposed to the elements. The bare substrate shows no evidence of filiform corrosion after the topcoat was damaged 12 months after the RCP001 was applied.

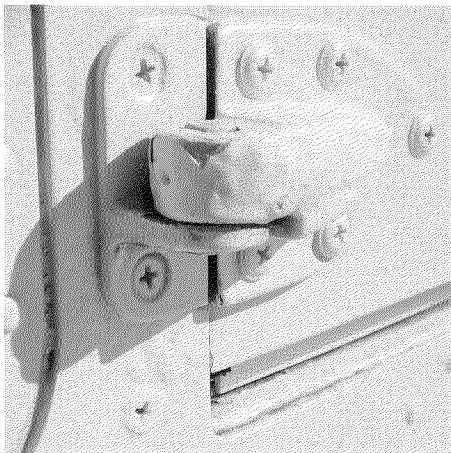
Pictured is a close up of the door hinge assembly. The hinge and forward structure was prepared and painted using standard chromate 2 pack system and the actual door skin side (right hand of picture) was prepared and painted at the same time using the AQL primer RCP001. It is evident that the left hand portion of the door assembly is showing significant filiform corrosion, while the right hand side of the assembly unit is showing no signs of corrosion.

The filiform corrosion which appears on the door hinge assembly coated using conventional aviation coating are prone to the formation of corrosion, but where the AQL system – RCP001 has been applied has result in little or no filiform corrosion present as the comparative system were applied at the same time.

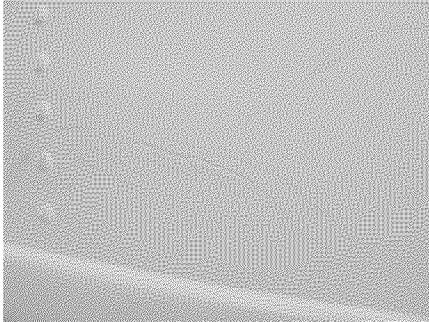
This picture is the aluminium float that had been damaged, brushed touched and is located below the water line.

Although the surface has been broken there is no sign of filiform corrosion in this instance.

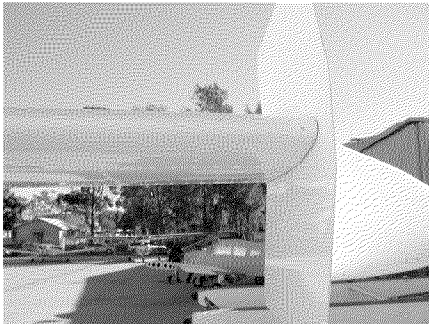
The empennage has some minor impact damage that has exposed the bare substrate.

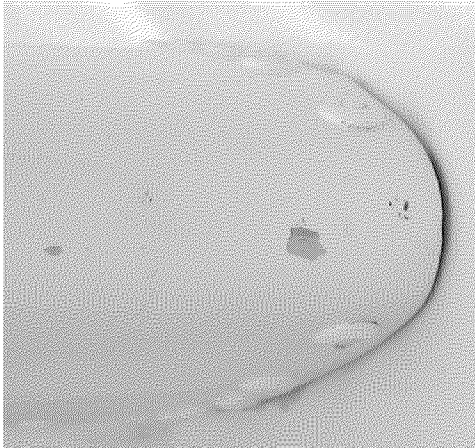
A close-up of this damage reveals that there is zero filiform corrosion. Although this part of the plane remains predominately outside of the water it is still susceptible to filiform corrosion due to the continuous salt water spray during take off and landing.

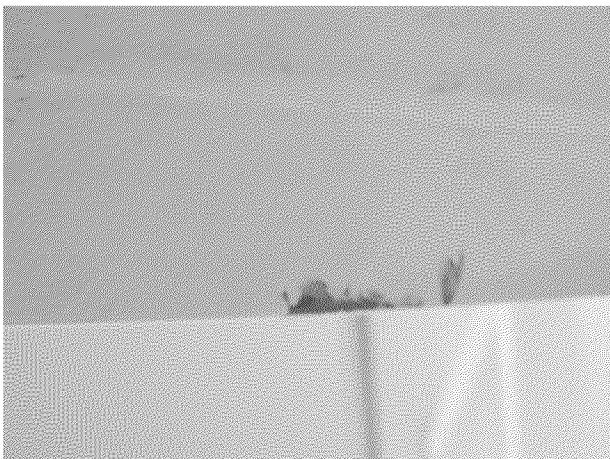
Pictured here is the float that has suffered some impact damage along the bottom edge.

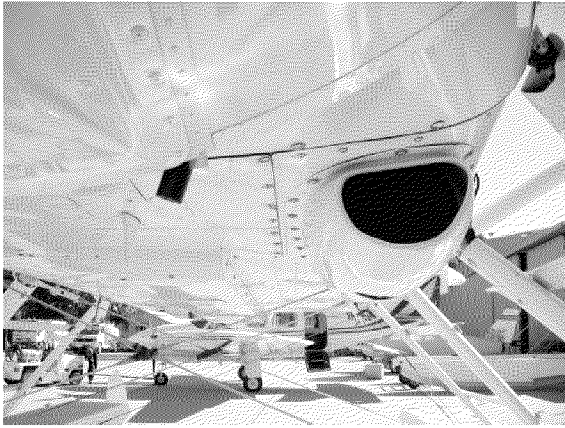
The lower access panel was not coated with RCP001 Aviation White Primer and there is significant corrosion present.

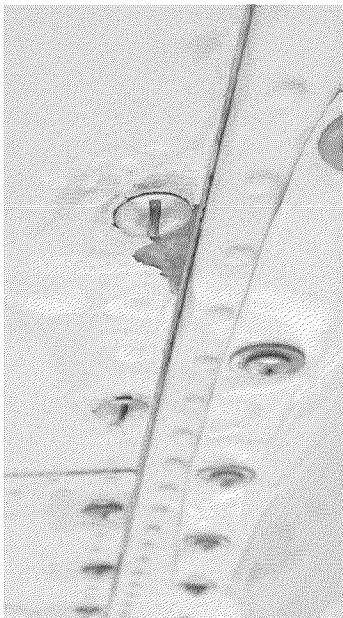
Pictured is a close up of the lower access panel, it can be clearly seen that where the dissimilar metal has instigated filiform corrosion.

Similar exposure on other parts of the aircraft (namely floats, door and empennage) indicate that had RCP001 Aviation White Primer been applied that filiform corrosion, while perhaps not prevented, would be at least limited significantly.

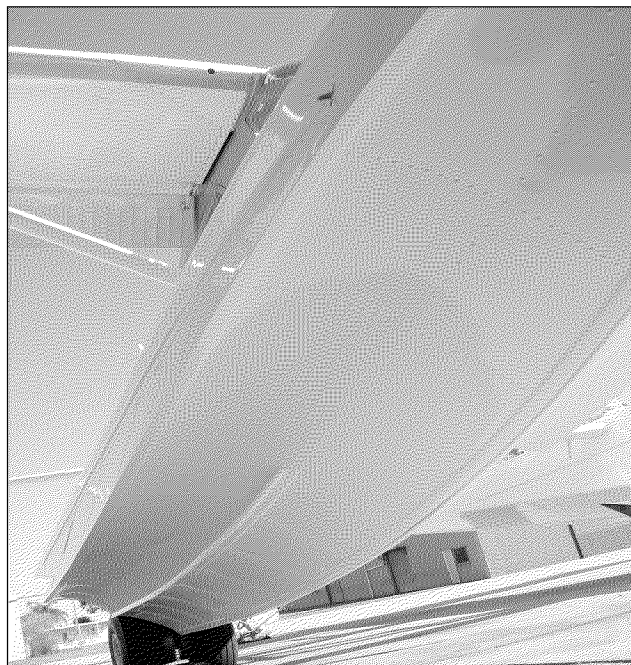
Float showing no signs of filiform corrosion

The aluminium floats are the most susceptible part of the aircraft to filiform corrosion, having been painted using the AQL primer system for 18 months, it would appear that these areas that have been coated with RCP001 Aviation White Primer have significantly delayed the onset of any form of corrosion.

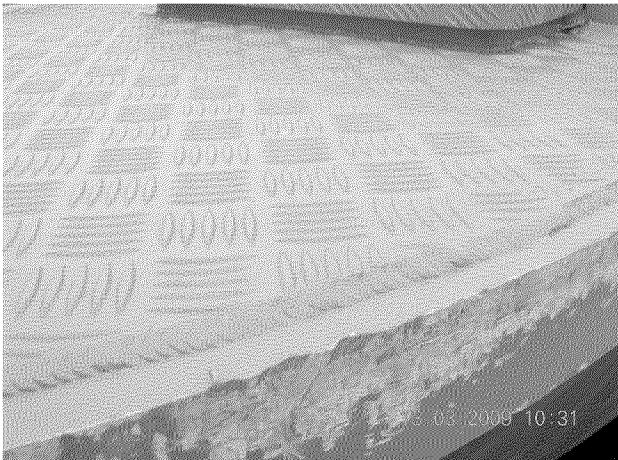
This deck has been repainted in the last two years. No additional primers were used on top of the existing AQL primer. It was simply cleaned and painted (with wear and tear expected).

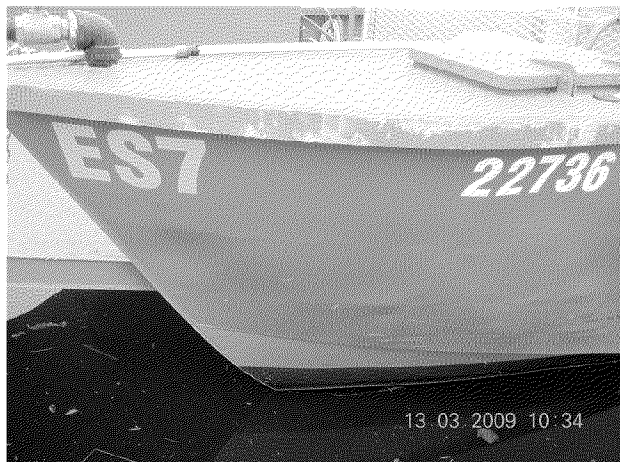
This shot was taken to demonstrate the level of bumps and scratches that the vessel encounters on a daily basis.

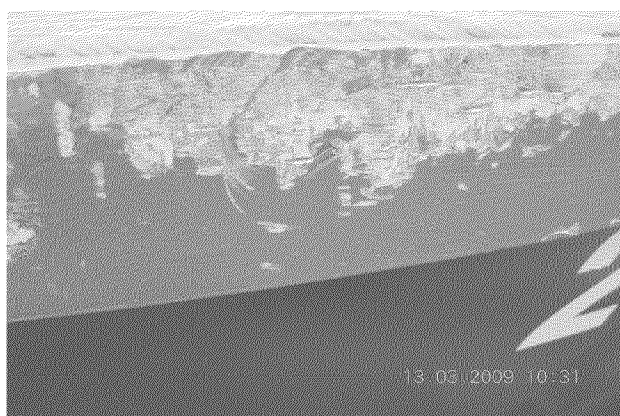
A close up demonstrates that there is no discernable signs of delamination or undercreep despite the exposed surface.

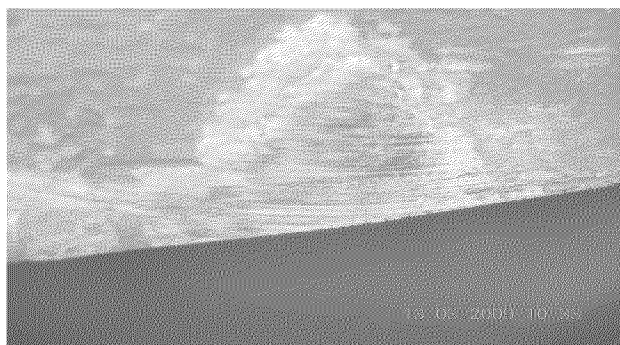
A further close up shows little to no corrosion. This indicates that the primer is still in tact below the painted surface.

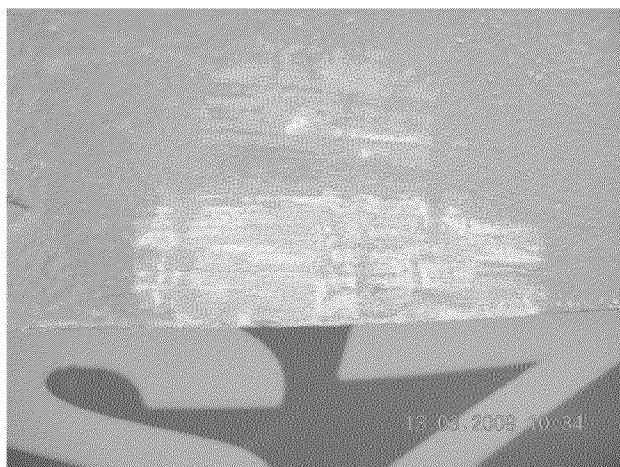
Ordinarily this kind of exposure would have been prone to filiform corrosion spreading from the exposed metal to beneath the paint layer.

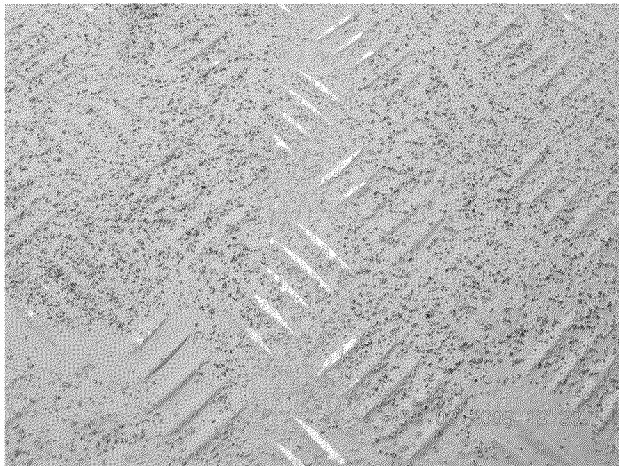
This deck has been repainted, but shows signs only of wear and tear.
